JUST ENOUGH

No more, no less than a Touring-bodied 1956 Alfa Romeo 1900 C SS needed

BY DAVID TRAVER ADOLPHUS
PHOTOGRAPHY BY ROY D. QUERY

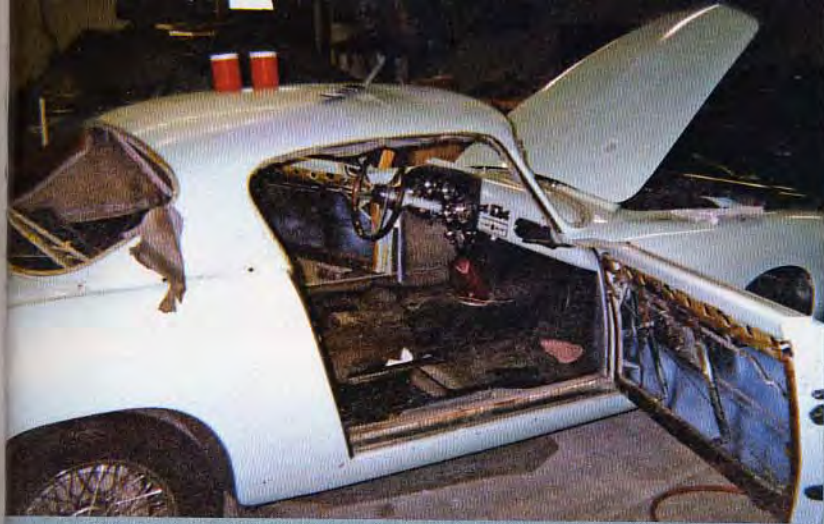
Careful removal, evaluation and storage of exterior trim is a vital first step. Everything was there, aluminum and chrome refinished

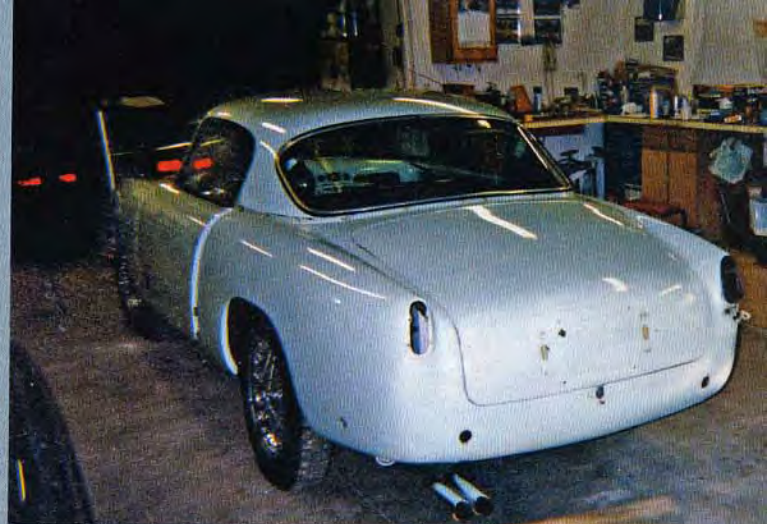
Next was to remove the glass, upholstery and interior. Restorer decided not to remove the complicated dash, loosened it enough for cleaning

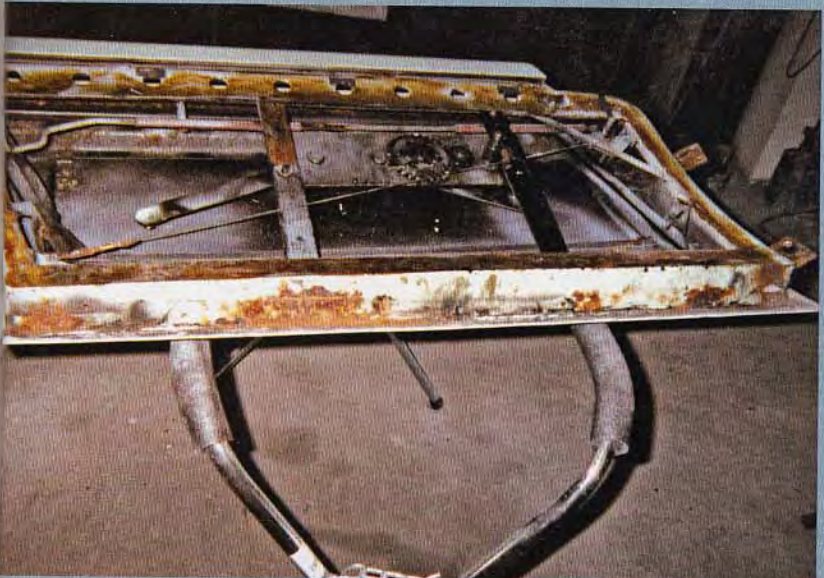
What looks like rust is adhesive from weatherstripping added later. Diagonal wire holds door square, in tension. New glass was cut locally

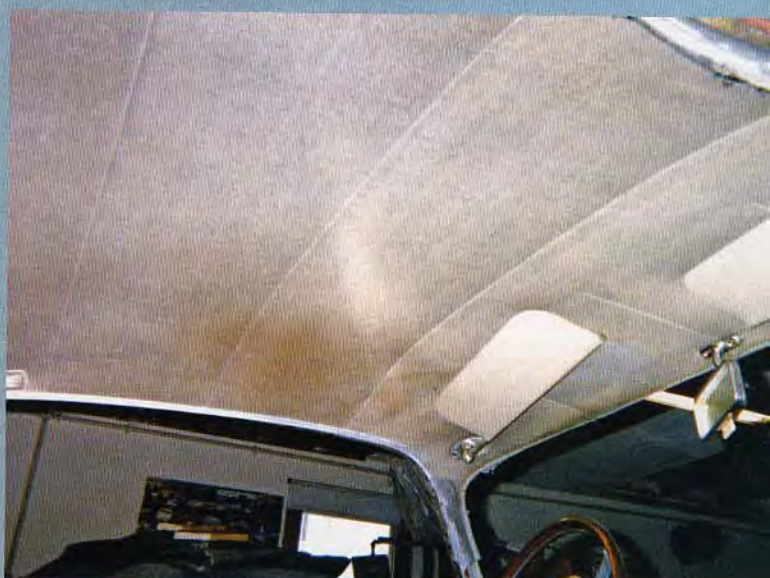
Owner and restorer originally planned to leave the interior intact, but closer examination revealed problems

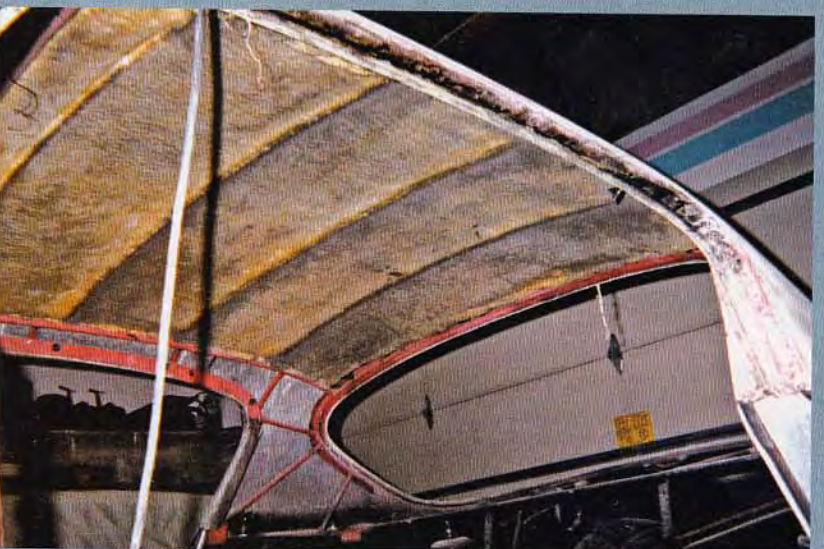
Looking toward the back window with the headliner fabric removed reveals Touring's unmistakable *superleggera* construction

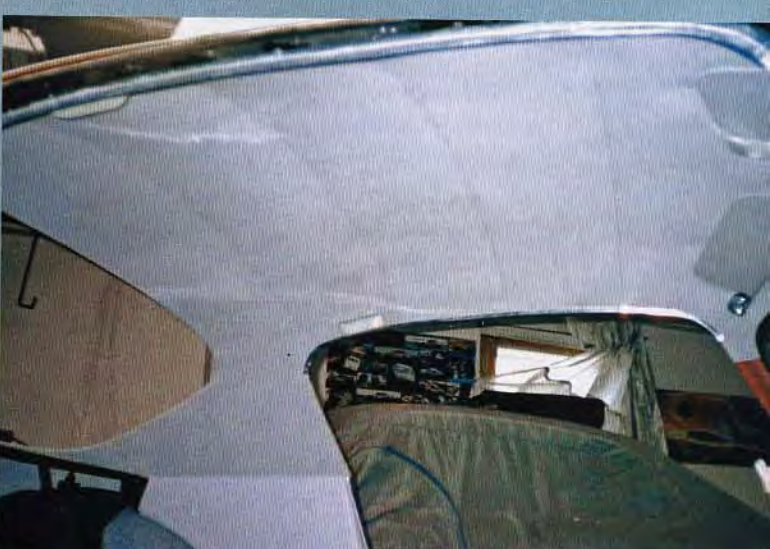
Three sleeves or darts at the front of the headliner are sewn around the roof support pipe. Edges are glued in, windows have to come out

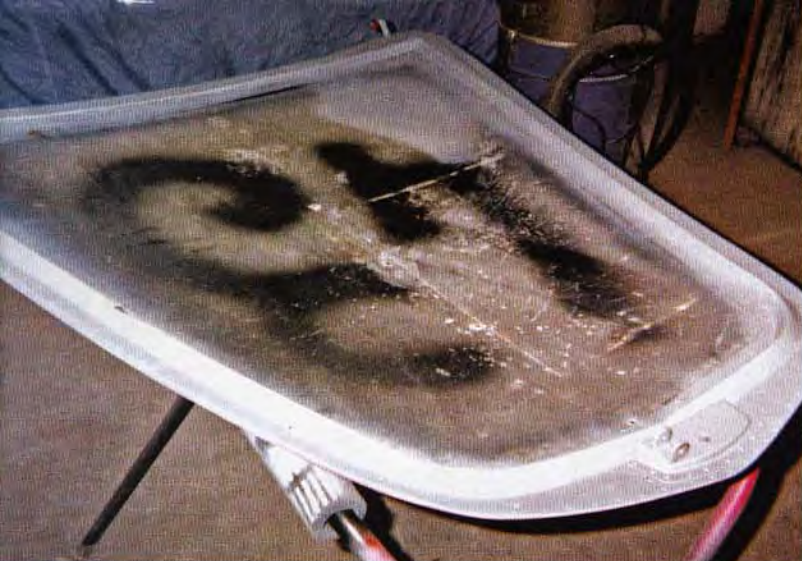
Number applied under the hood at Touring. A handbuilt car, doors and rear decklid are also marked, and don't interchange with any other car

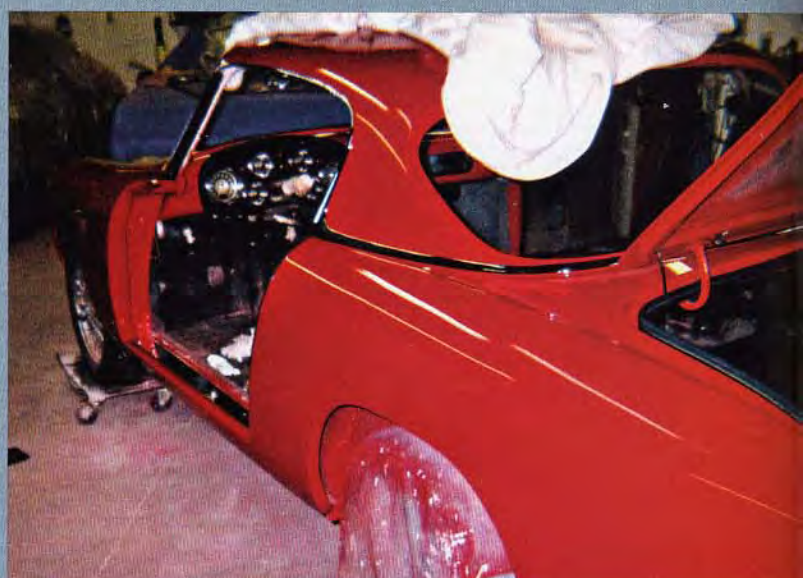
Paint was razor-stripped off and Touring's primer left on in most places; Chromalite body filler used on the uneven aluminum body shell

When he first looked at it, Brian thought about sanding and blocking, and painting over the current paint. When the first coat or two came off easily with a razor blade and heat gun, he took it all off. "I don't like using chemical strippers. I used to use them, and they always came back and bit me. When you use a chemical stripper, they tell you to leave it on there, strip it off, and then you have to wash the surface. If you had a rust spot where it was pitted, and the stuff got in there, you couldn't get it all out." On the front end and rear decklid, where bodywork was required, he took it down to bare metal, but on most of the car he stopped at the Touring's hard skim coat of filler.

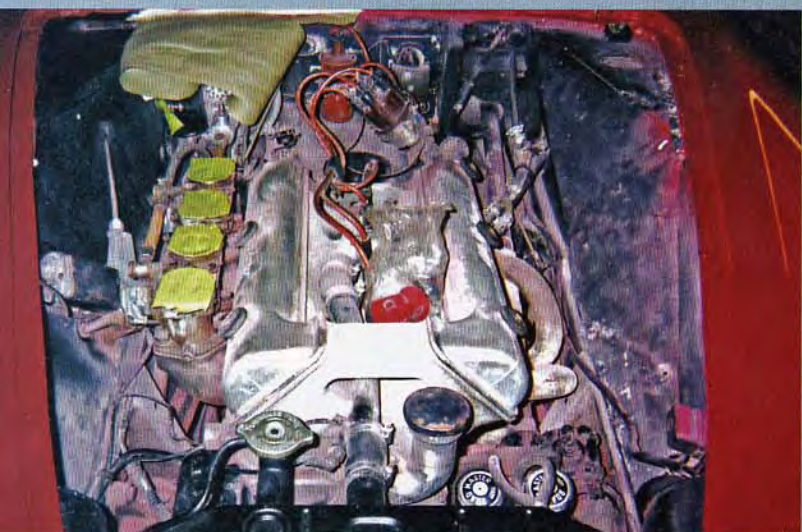
Inner fenders are now covered with quilting, so overspray wasn't an issue. Small panel in the wheel well gives access to belts and hoses
